TUNNEL IDENTIFICATION AND DESCRIPTION

INSPECTION TEAM: T. Suthers, J. Wolfe (Burgess & Niple, Inc.)

FIELD INSPECTION REPORT**STRUCTURE NO. 8-8****INSPECTION DATE: 12/13/05**

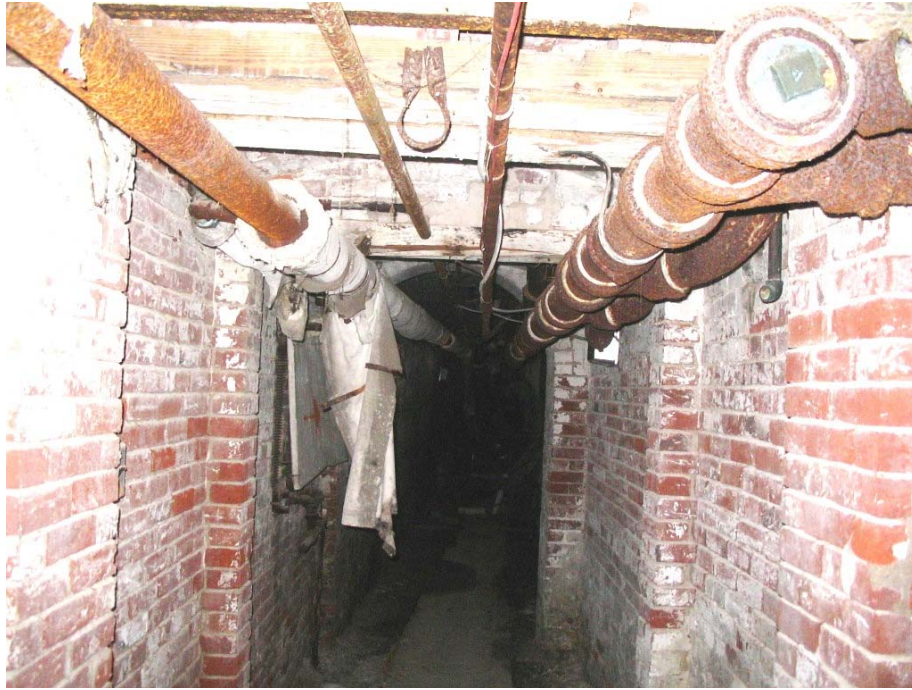
Photo 1: East portal

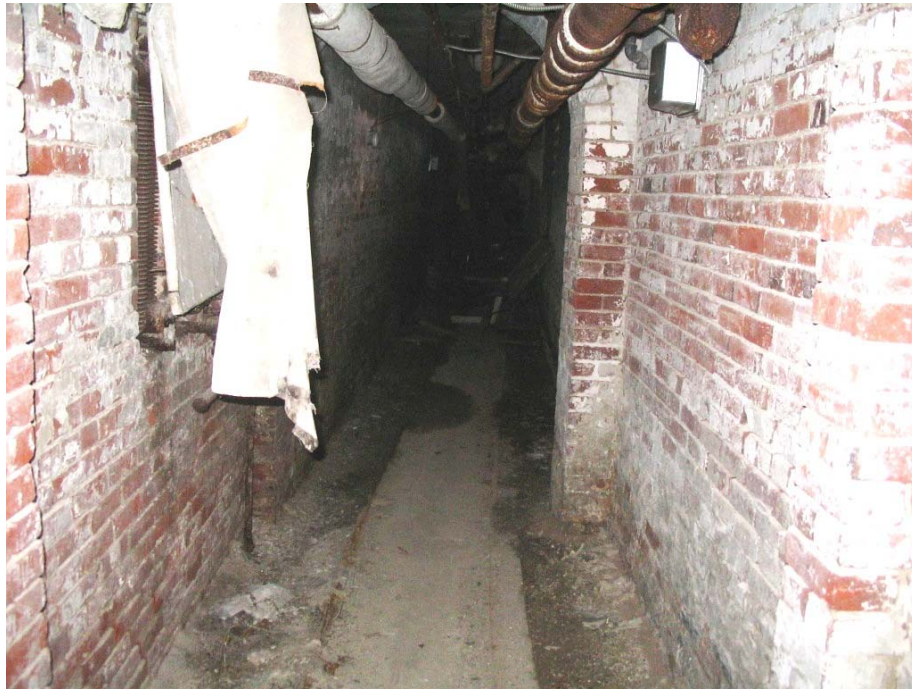
Photo 3: General view of lining, looking east

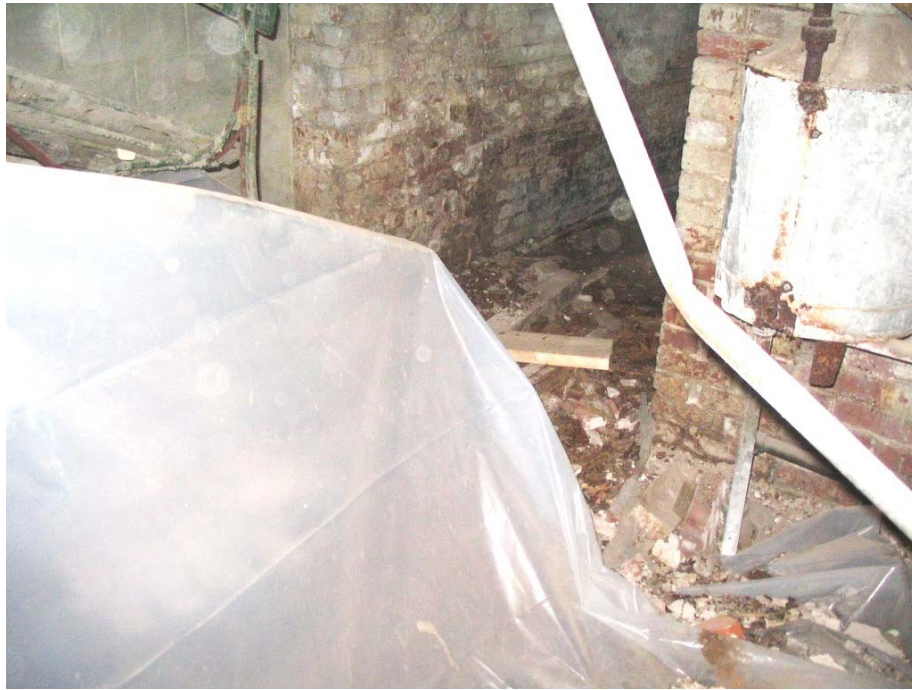
Photo 5: Debris on floor, looking east from west portal

1. Remove debris from floor, 2 CY.
2. Replace electric lines, 80 LF.
3. Replace lighting conduits and wiring, 80 LF.

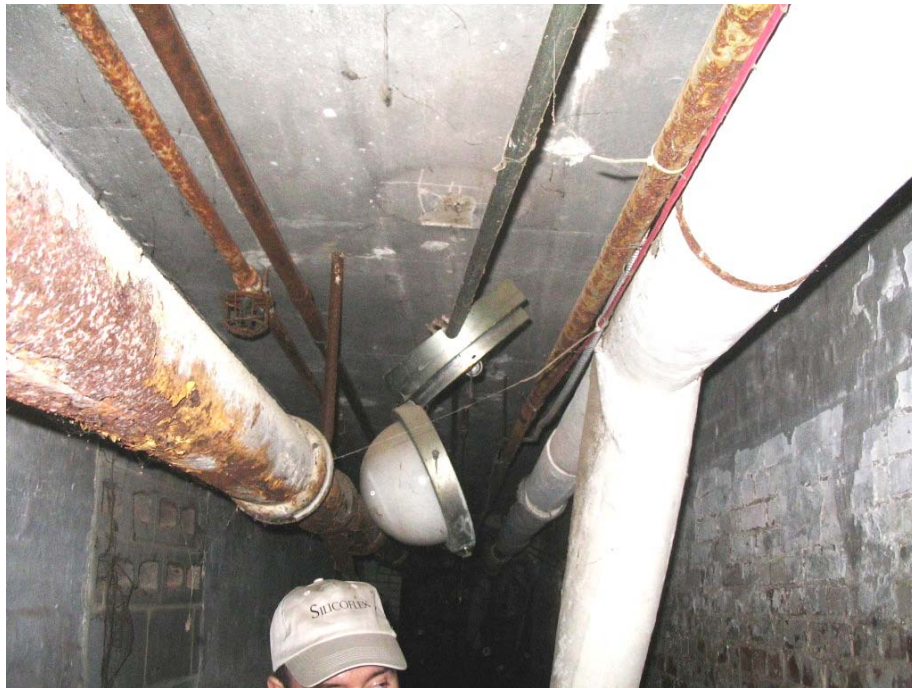
| 402.1,2,3 | Moderate corrosion on pipes and conduits. |

Photo 6: Damage light fixture; Note corrosion on pipe and conduits

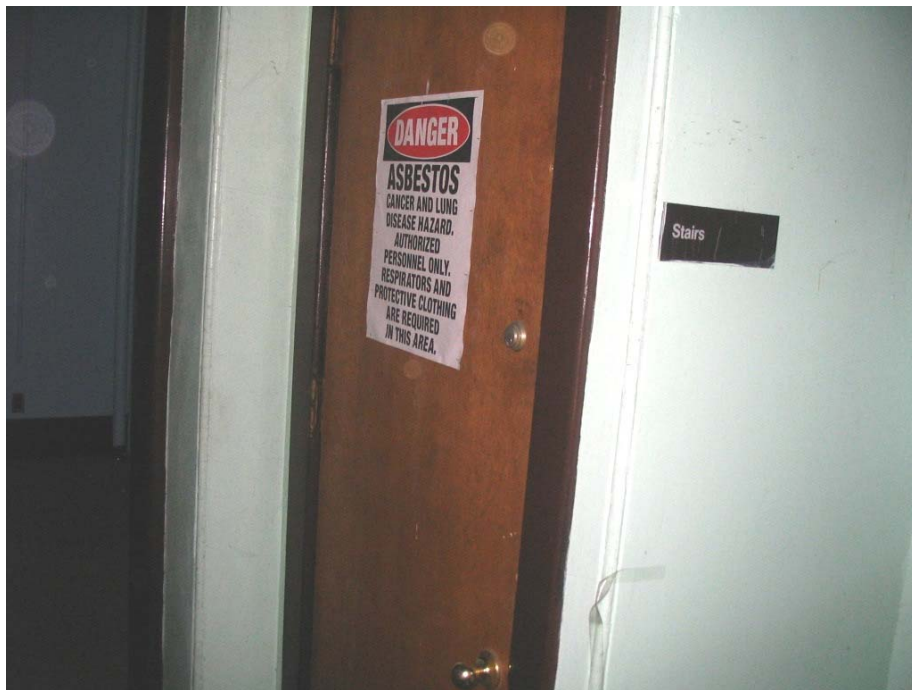
Photo 2: West portal; Note bolted shut door

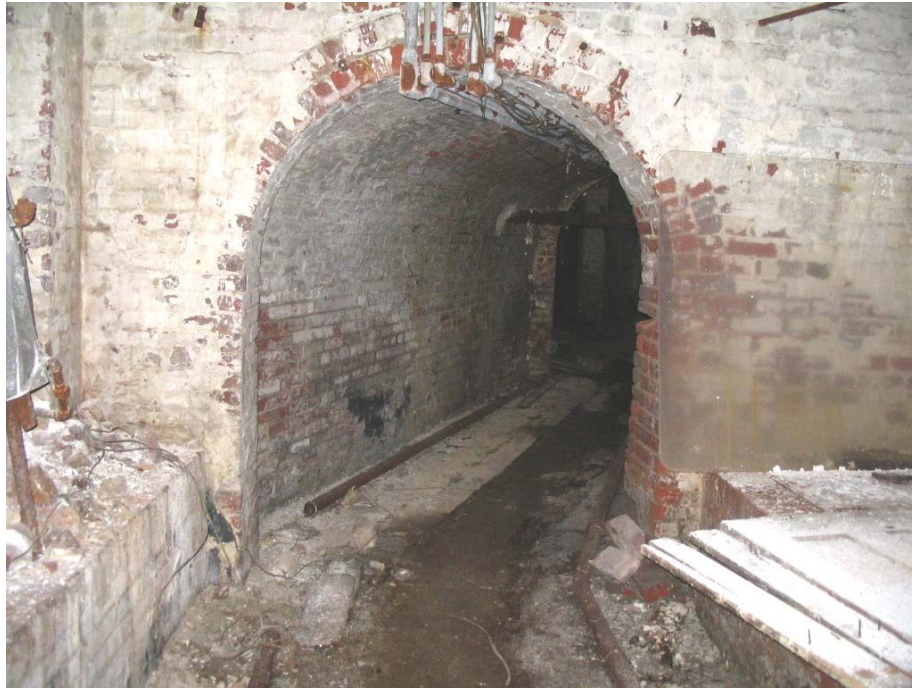
Photo 1: North portal

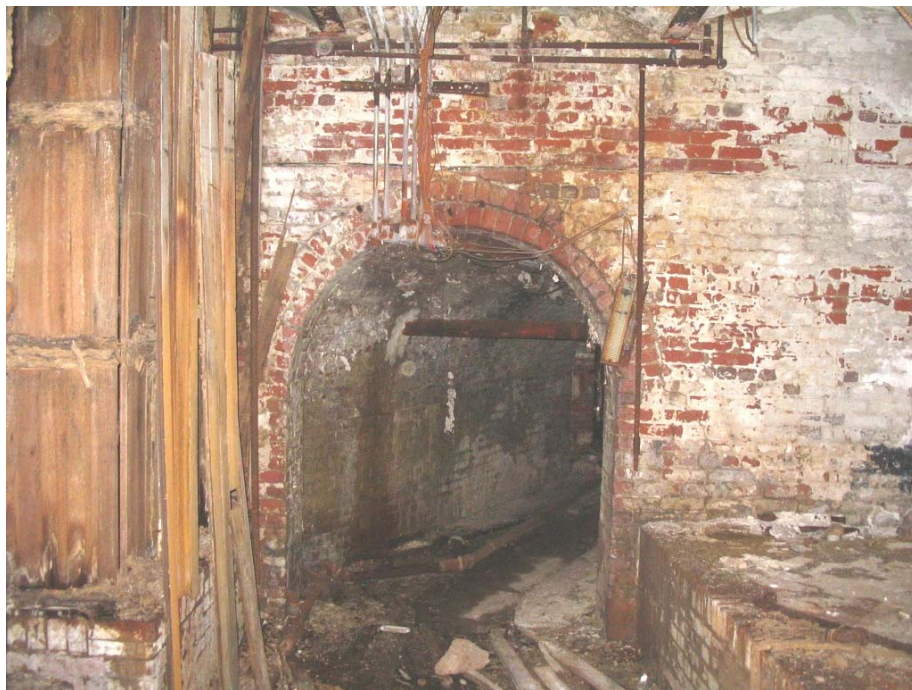
Photo 2: South portal

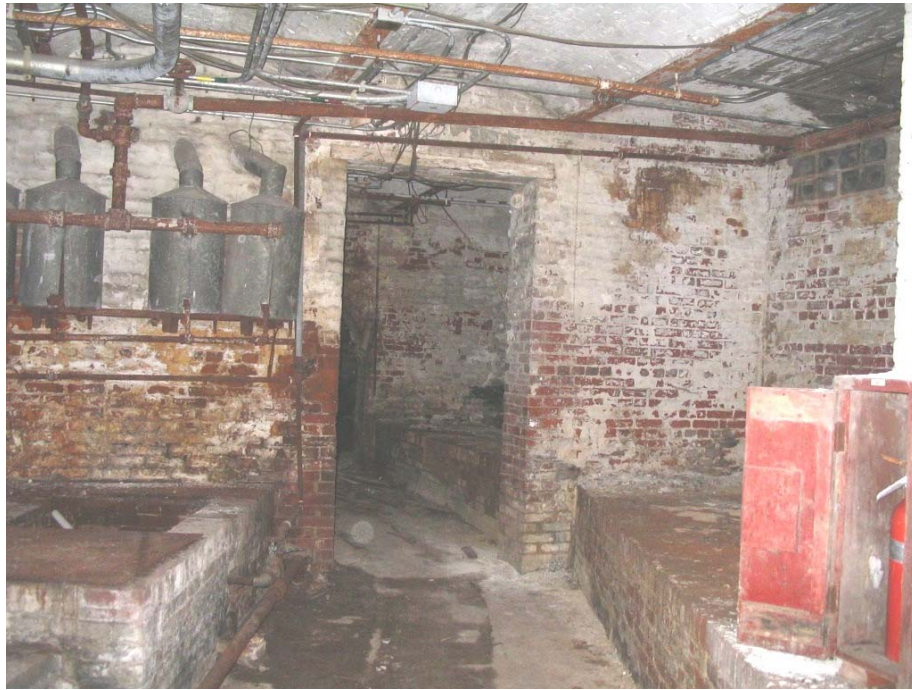
Photo 3: Looking north from Building 29

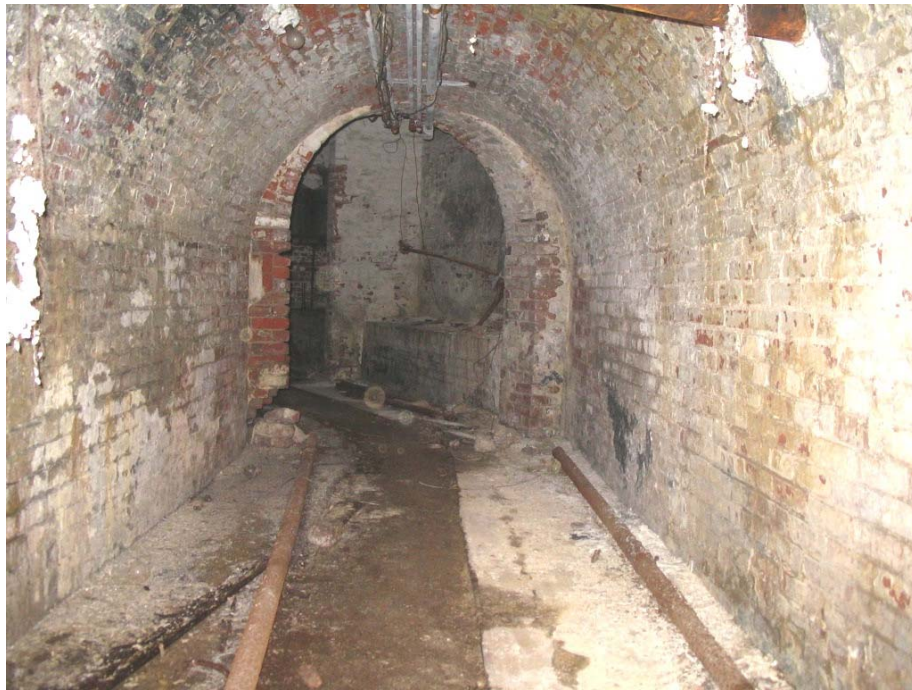
Photo 4: General view of lining, looking toward north portal;
Note water seepage on west wall

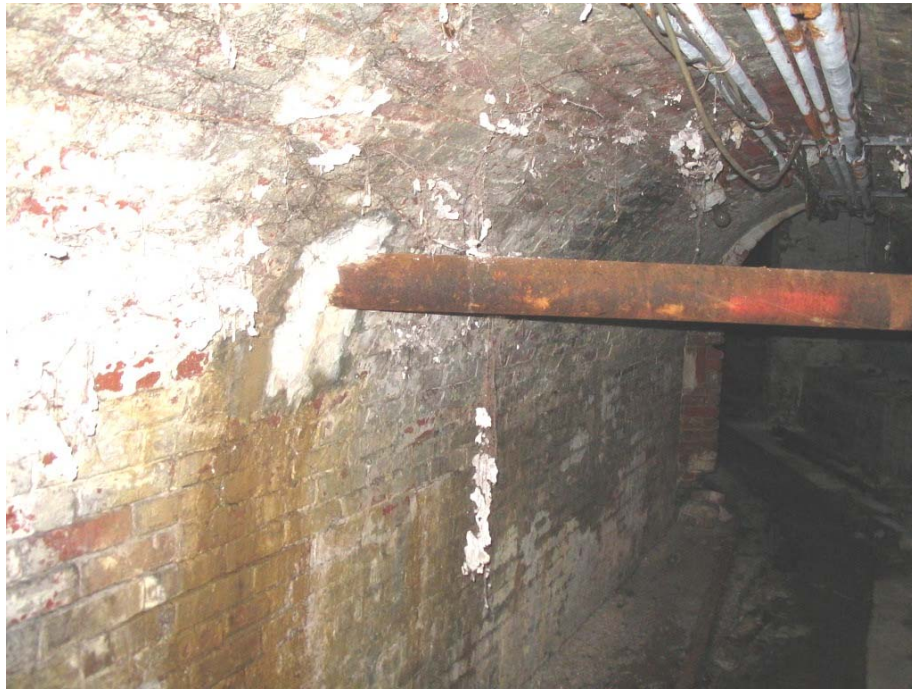
Photo 5: Water seepage through west wall below pipe near south portal;
Note sagging electric line and corrosion on conduits

1. Replace electric lines, 65 LF.
2. Replace lighting conduits and wiring, 65 LF.

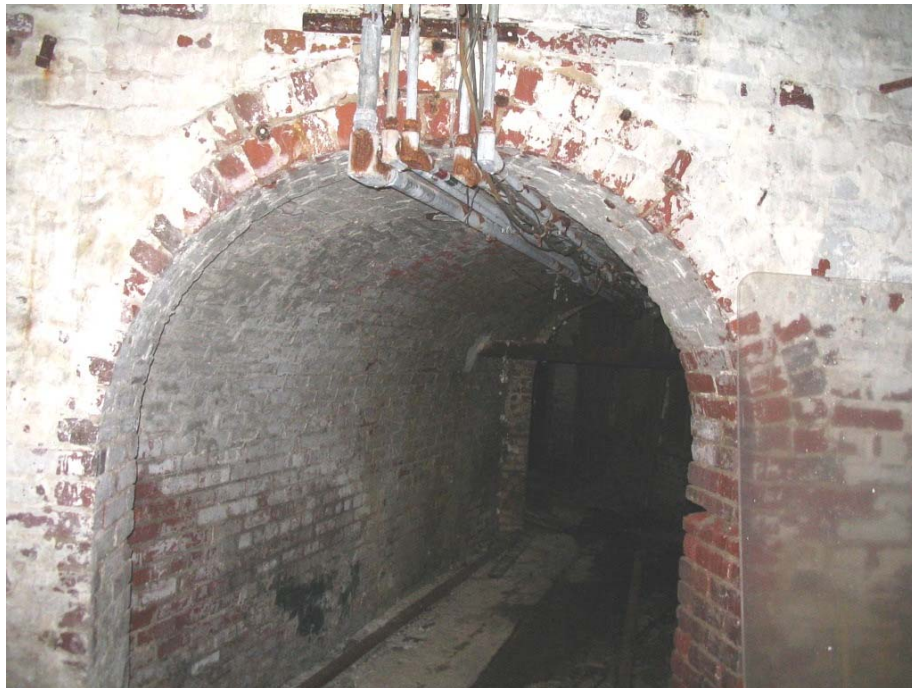
Photo 6: Deteriorated mortar between bricks around top of arch, north portal;
Note corrosion on conduits

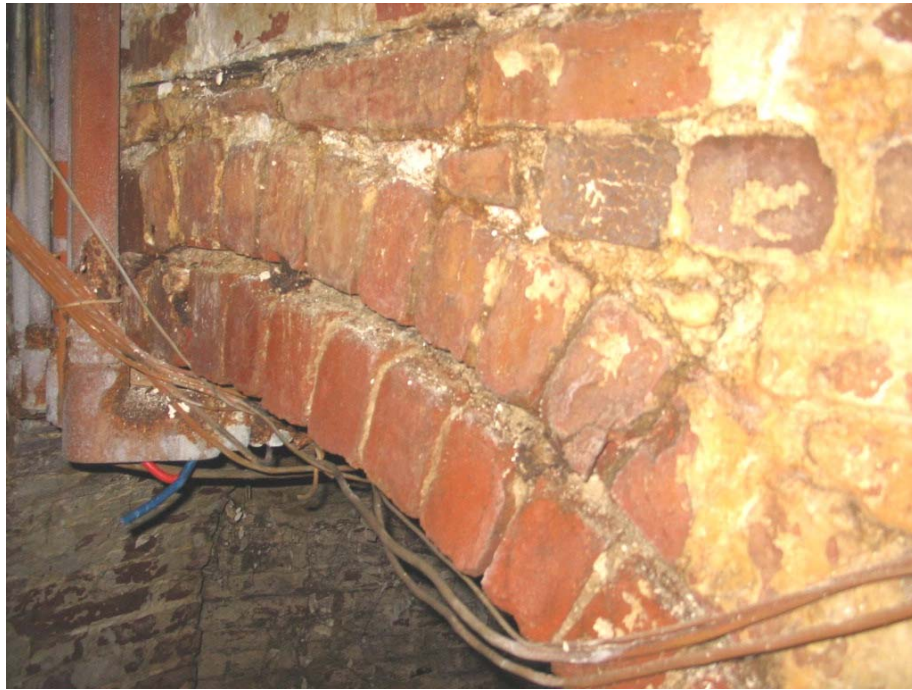
Photo 7: Deteriorated mortar between bricks around top of arch, south portal

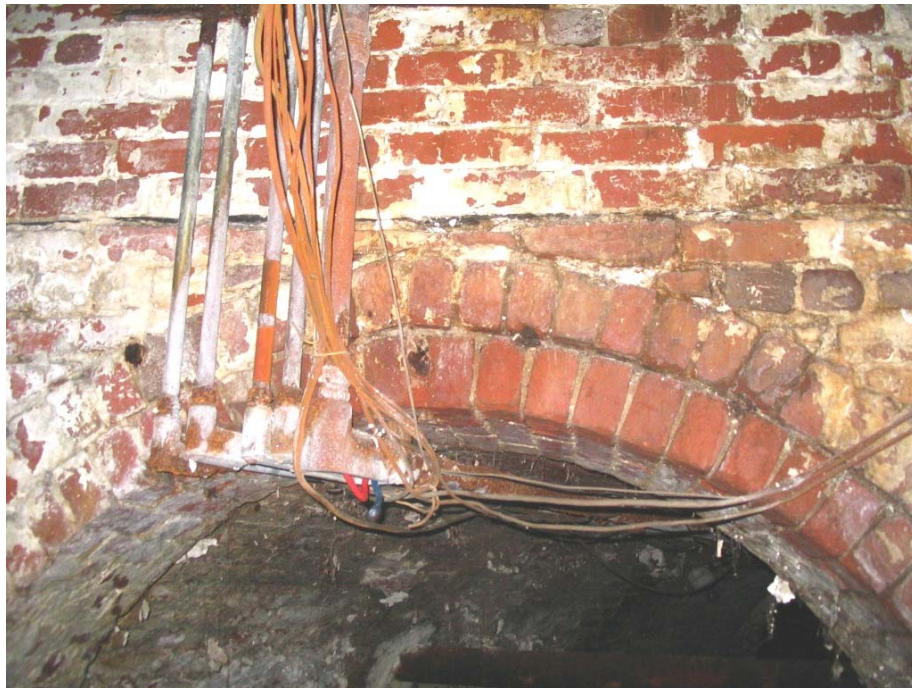
| 402.1,2,3,6 | Moderate corrosion on pipes and conduits. Exposed wiring on conduit at south portal. Sagging and corroded wiring in areas. |

Photo 8: Corrosion on conduits at south portal; Note exposed wires

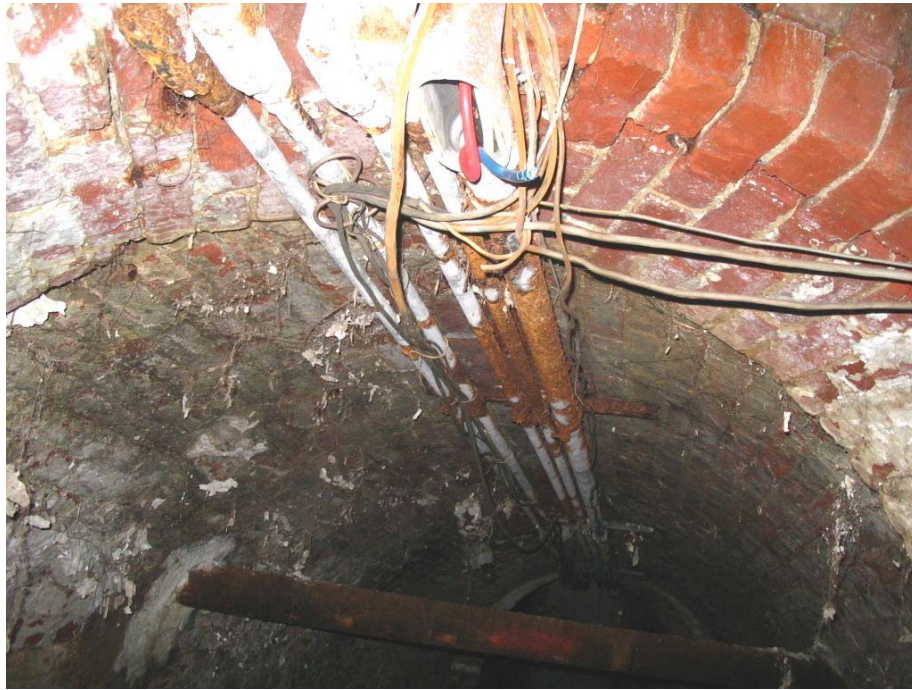
Photo 9: Corrosion on conduits

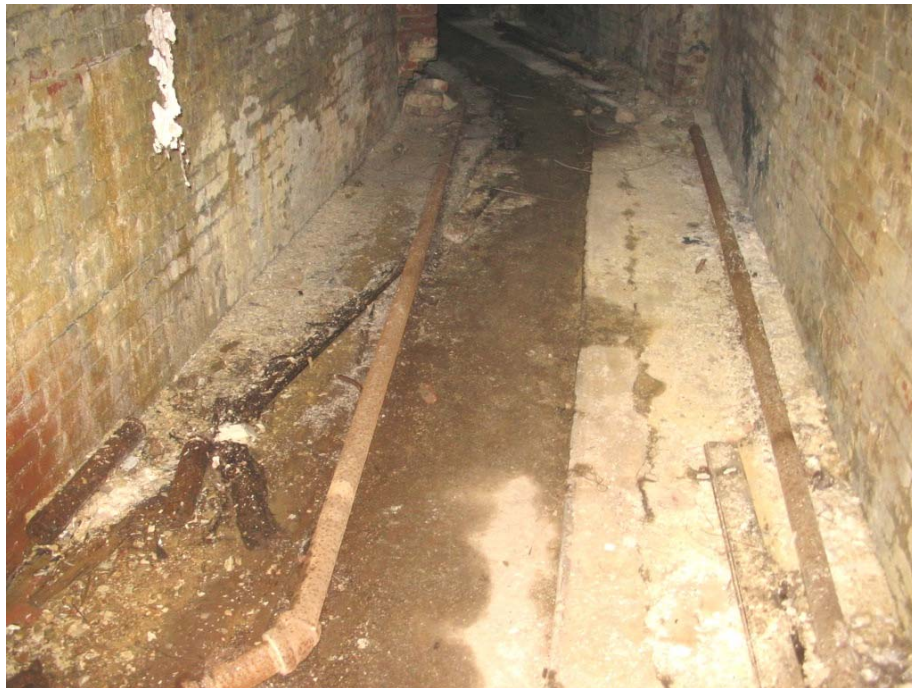
Photo 10: Debris and piping on floor, looking north from south portal

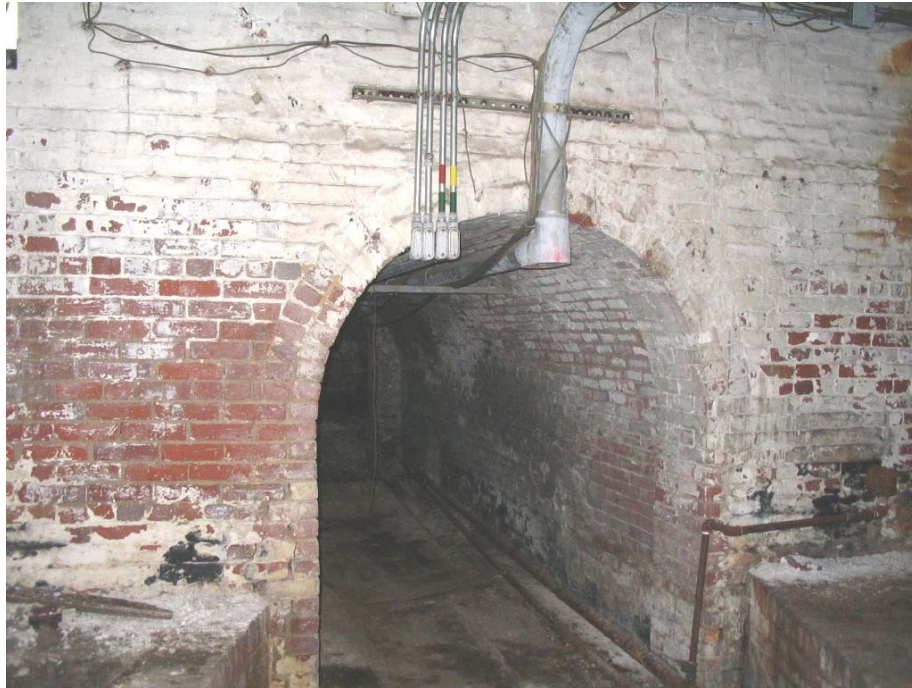
Photo 1: North portal

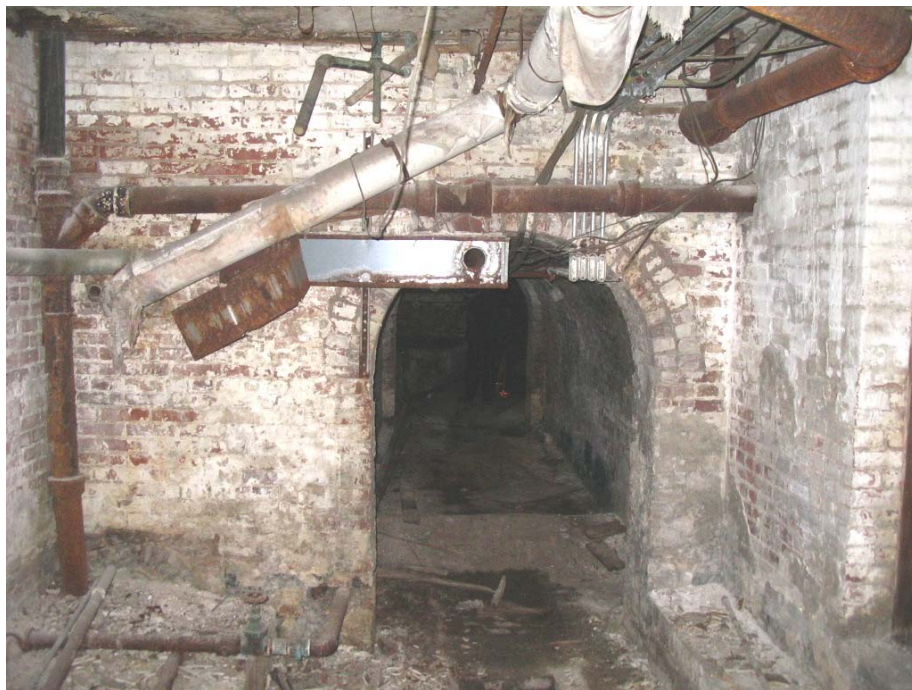
Photo 2: South portal; Note utility concrete cap across floor

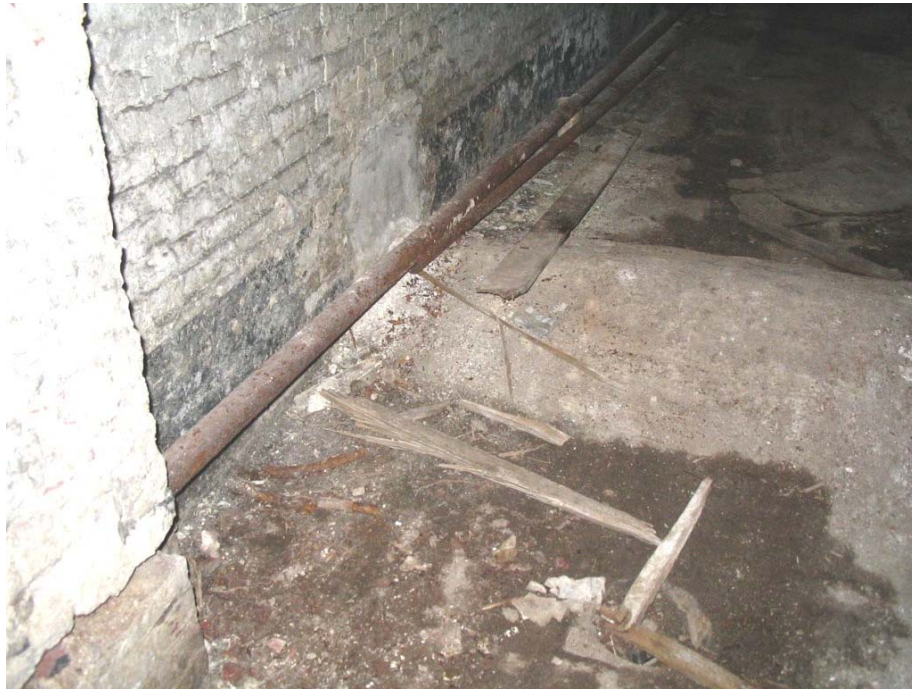
| 59.3 | Floor is covered with dirt and debris. Floor is out of level in some areas. Utility concrete cap passing across tunnel floor creates a tripping hazard. |

Photo 3: Debris on floor and corroded pipe along west wall;
Note utility concrete cap across floor

1. Replace electric lines, 55 LF.
2. Replace lighting conduits and wiring, 55 LF.
3. Remove debris from floor, 2 CY.

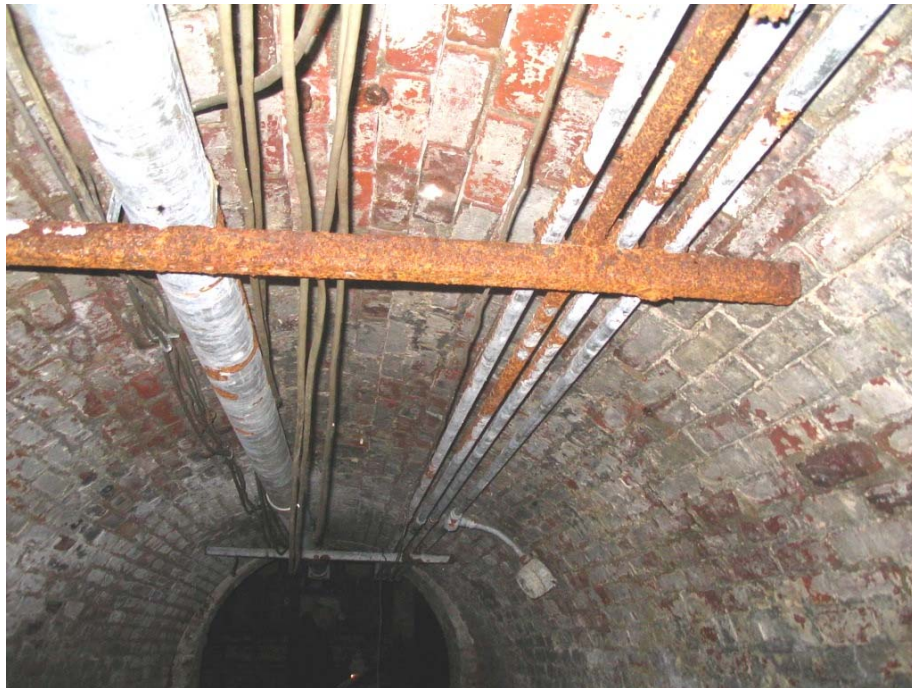
| 402.1,2,3,6 | Moderate to heavy corrosion on pipes and conduits. Sagging wires in several locations. |

Photo 4: Corrosion on pipe and conduits along ceiling;
Note corrosion on pipe crossing below conduits near south portal

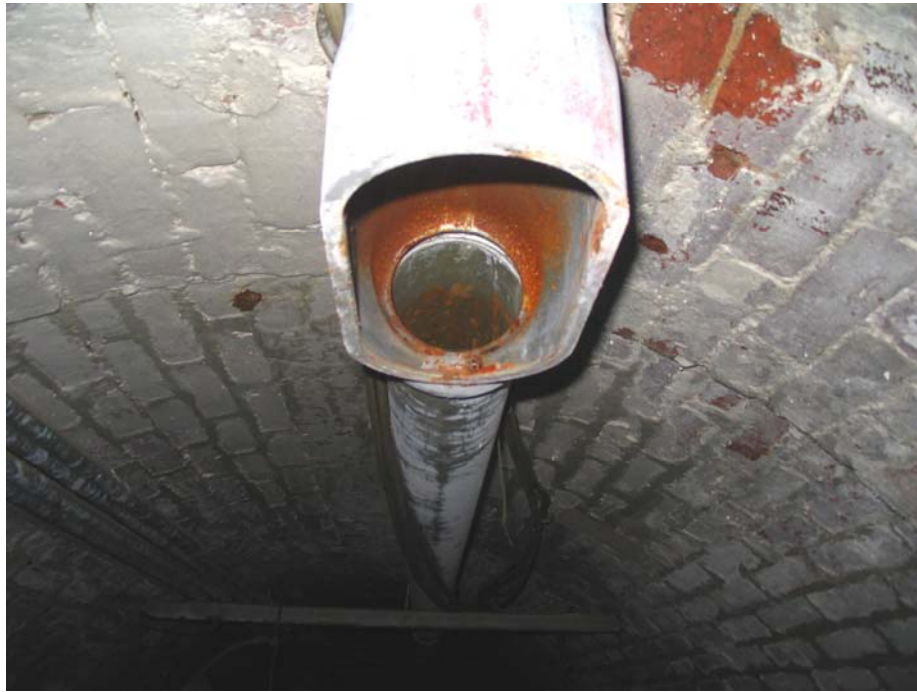
Photo 5: Open junction box on conduit at north portal

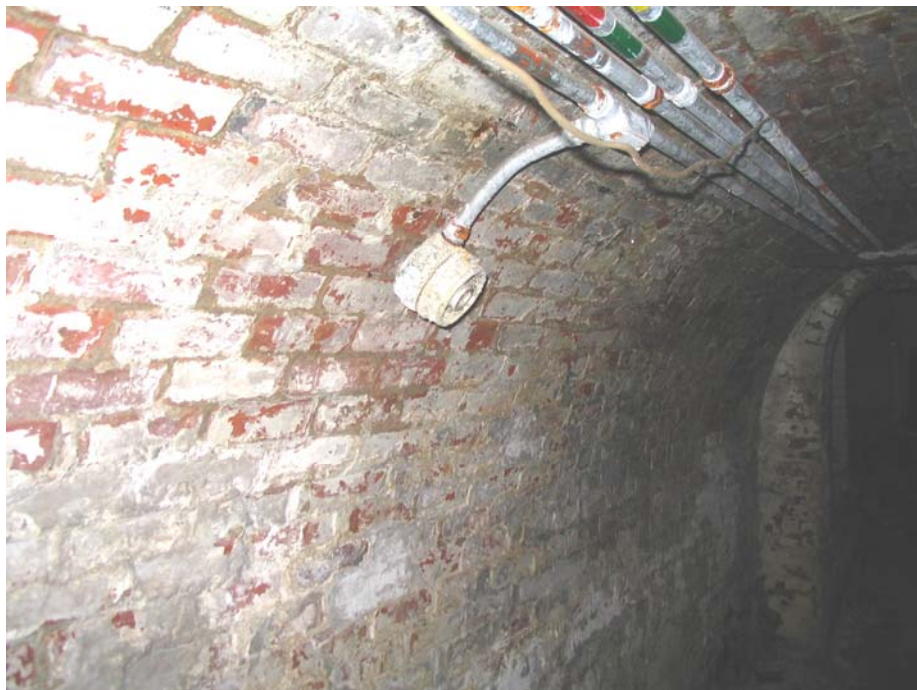
Photo 6: Damaged light fixture on east wall

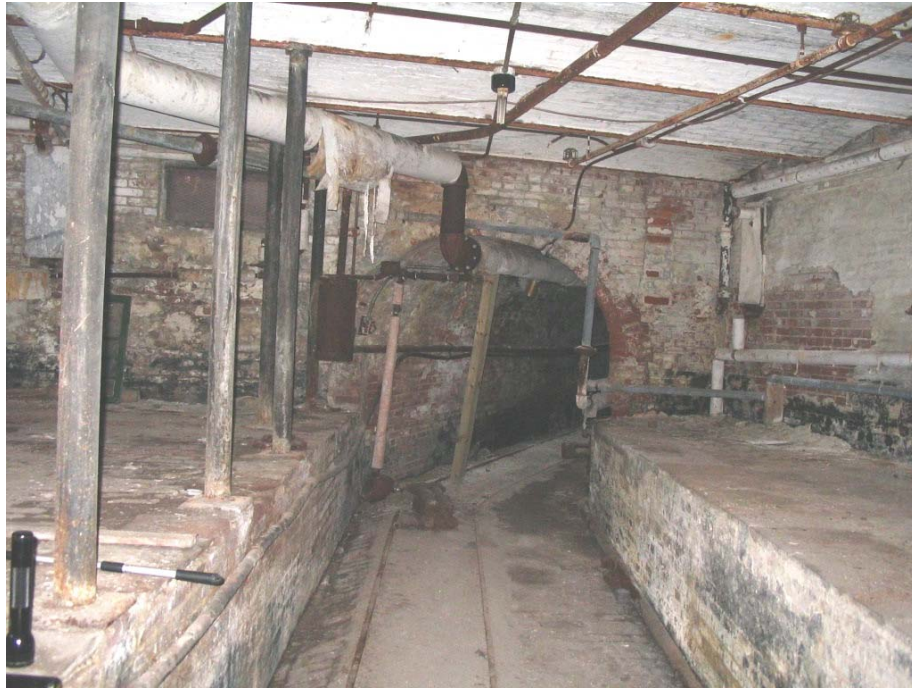
Photo 1: West portal in basement of Building 31, Atkins Hall

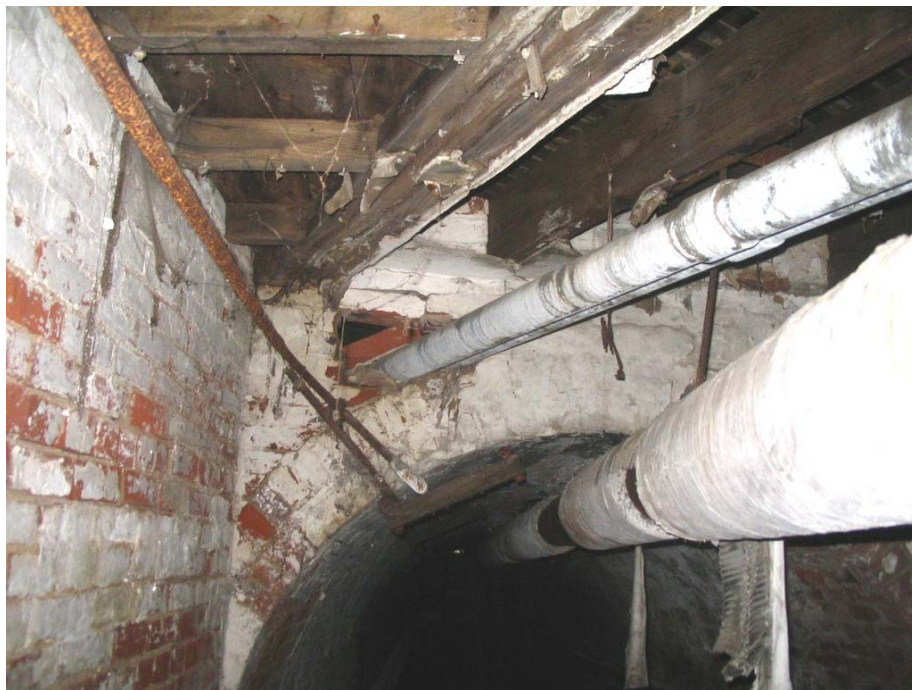
Photo 2: East portal near Building 32, Relief

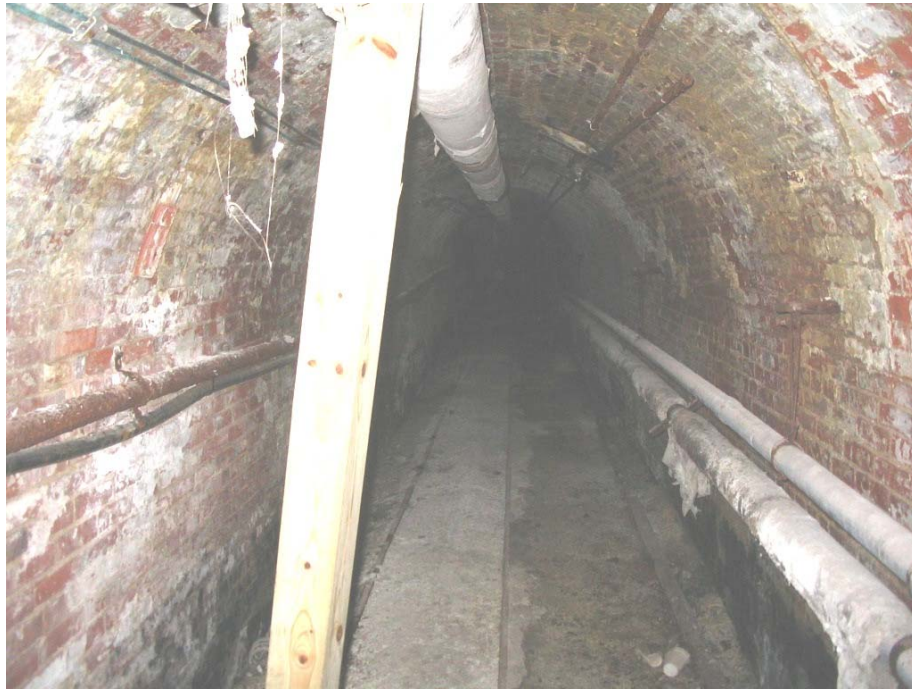
Photo 3: General view looking east from west portal

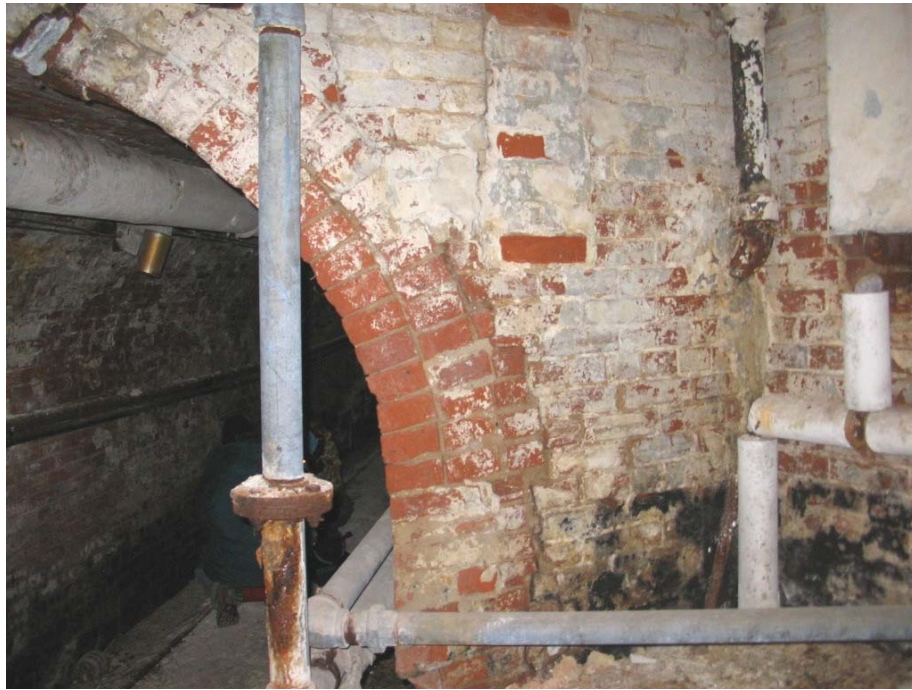
| 59.2 | Vertical crack through bricks on east side of south portal. Busted bricks for water pipes routing through north portal. |

Photo 5: Vertical crack in bricks on east side of south portal

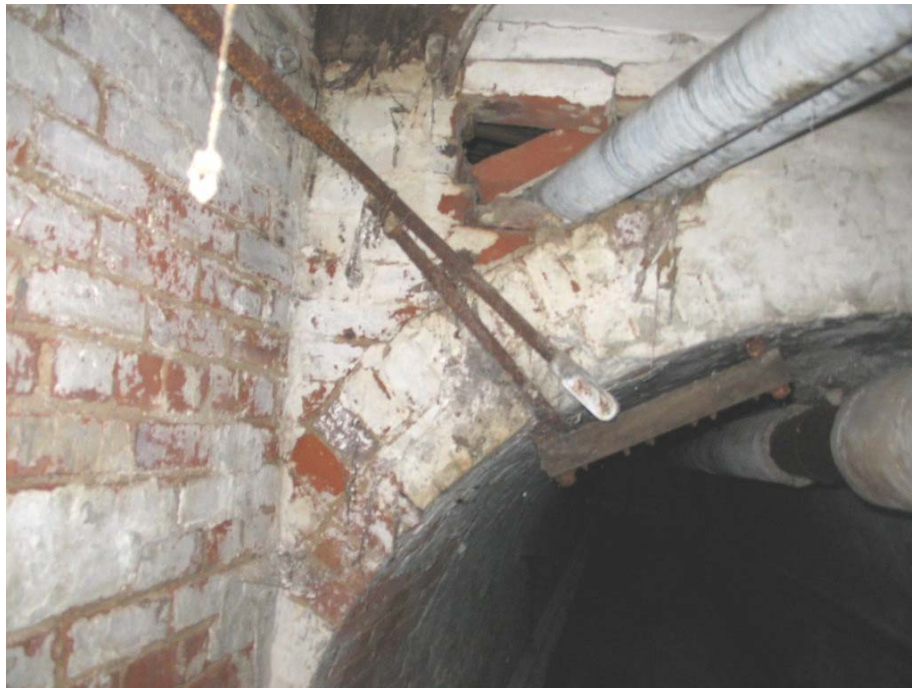
Photo 6: Busted bricks for routing water pipes through north portal

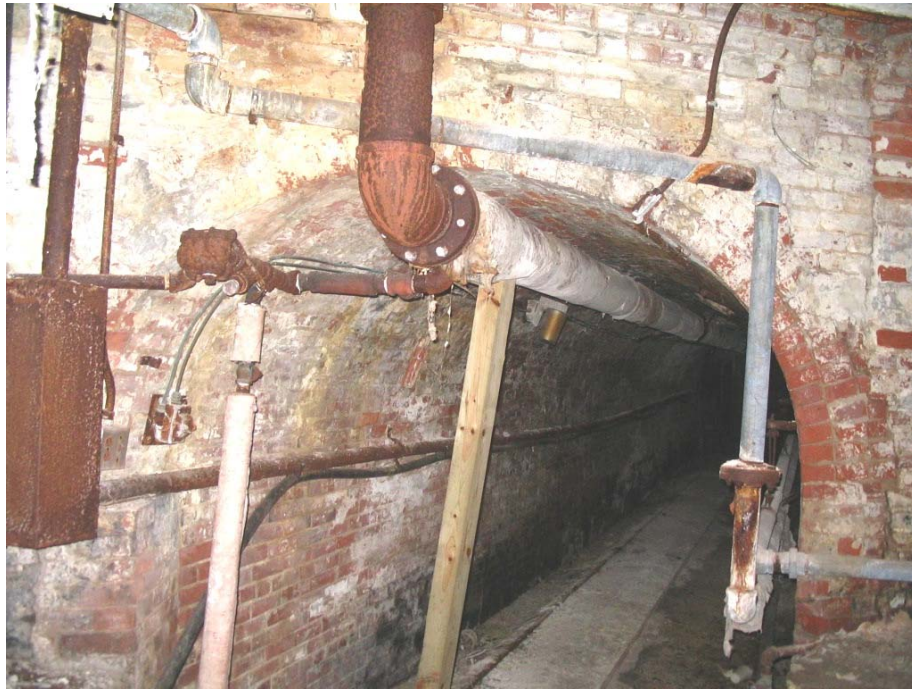
| 402.1,2 | Steam and water pipes have moderate to heavy corrosion. Steam pipe is supported by timber shoring at south portal. |

Photo 7: Corrosion on steam and water pipes at west portal;
Note timber support below steam pipe

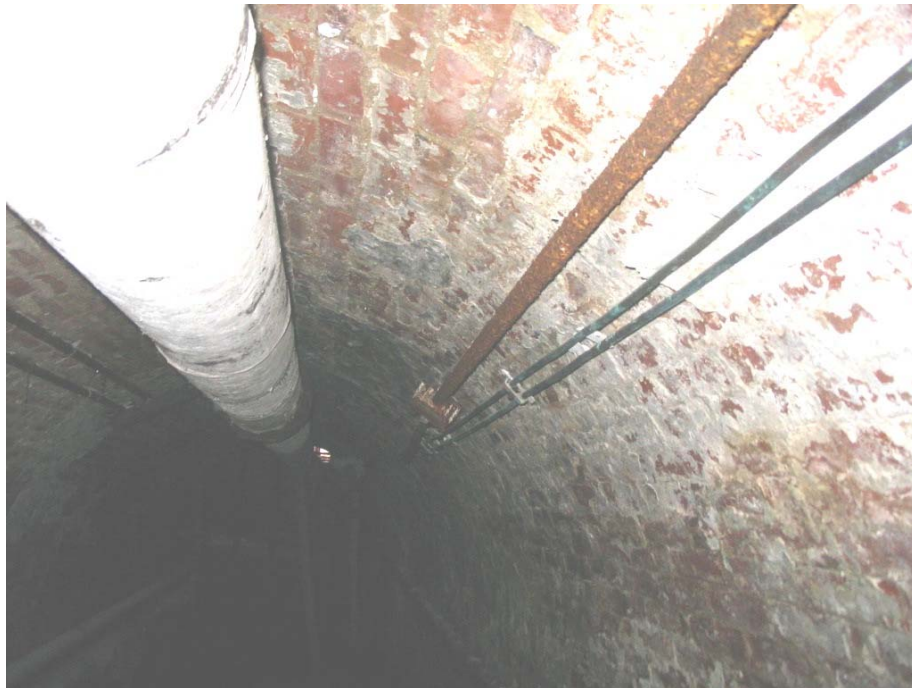
| 402.3 | Electrical and lighting conduits have moderate to heavy corrosion. |

Photo 8: Typical corrosion on lighting conduit

1. Replace electrical lines, 60 LF.
2. Replace lighting conduit and wiring, 60 LF.

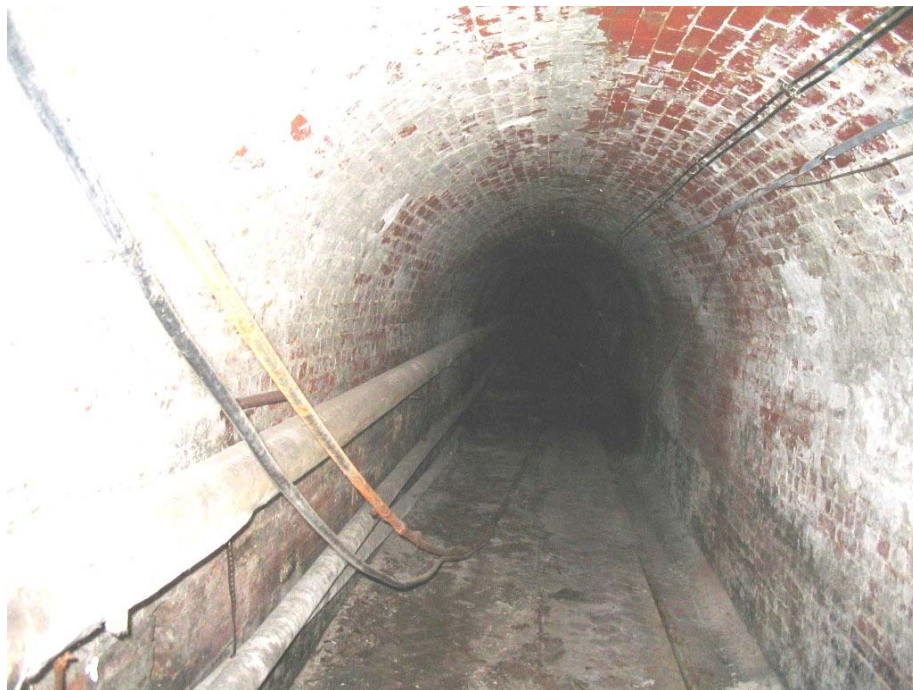
Photo 2: South portal; Note downed and sagging electrical lines

1. Replace electrical lines, 75 LF.
2. Replace lighting conduits and wiring, 75 LF.

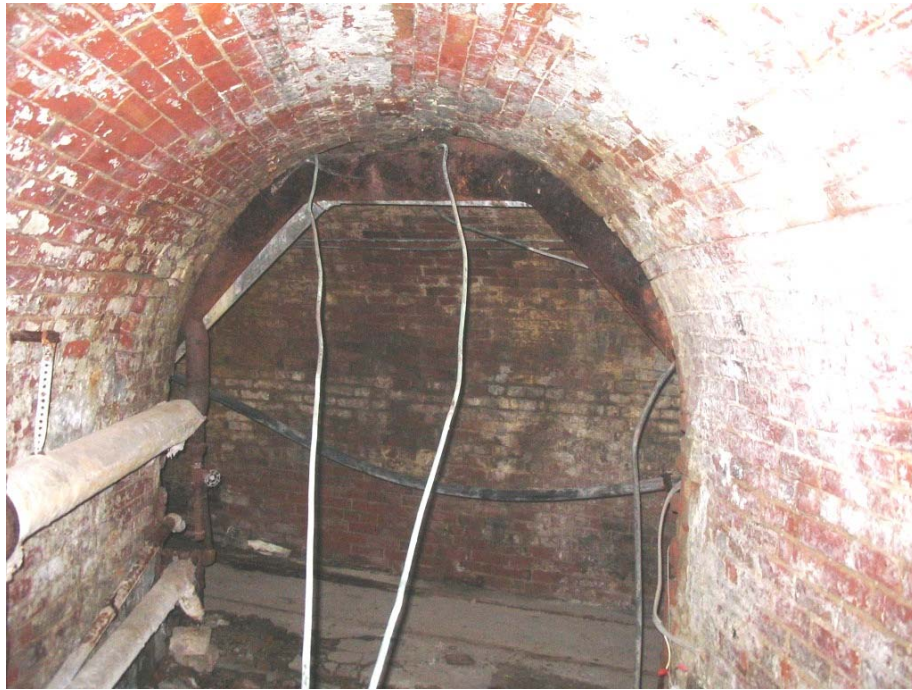
Photo 3: Downed wiring at north end of tunnel, junction with tunnel 31-44

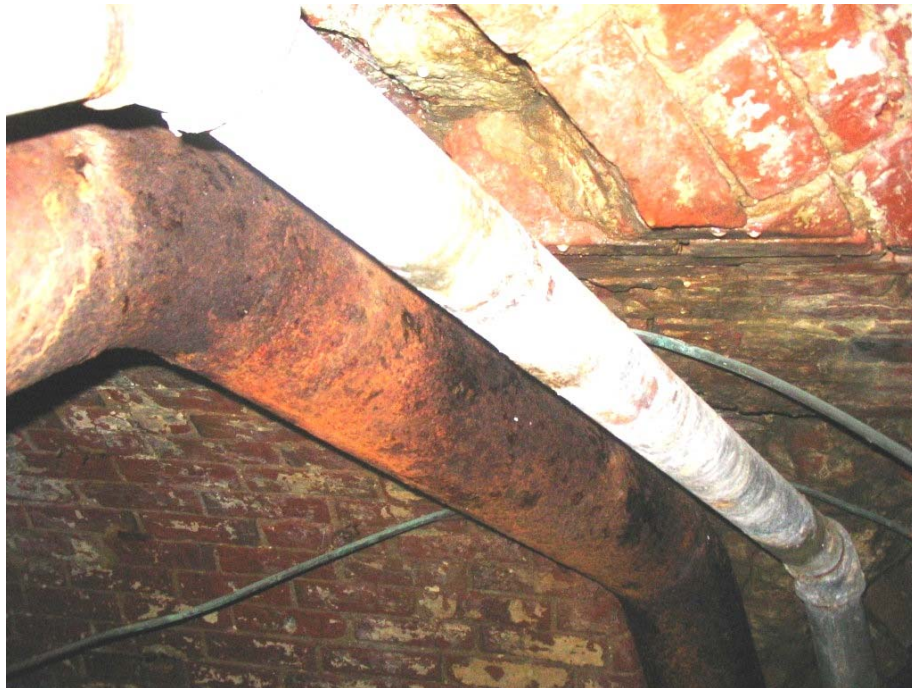
| 402.1,2 | Moderate corrosion of steam and water lines. |

Photo 4: Corrosion on steam and water pipes, north portal

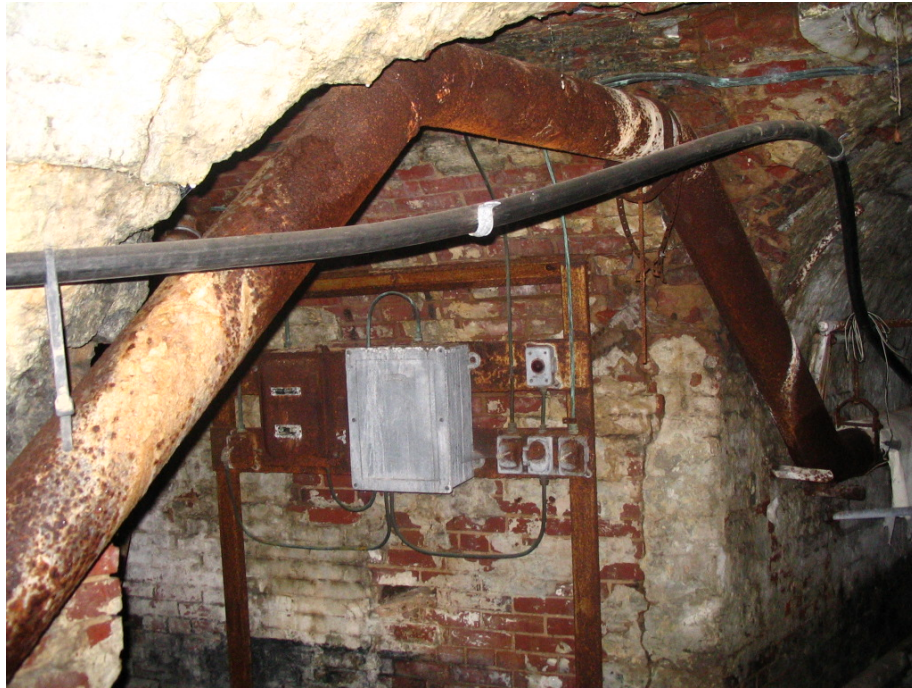
Photo 1: North Portal

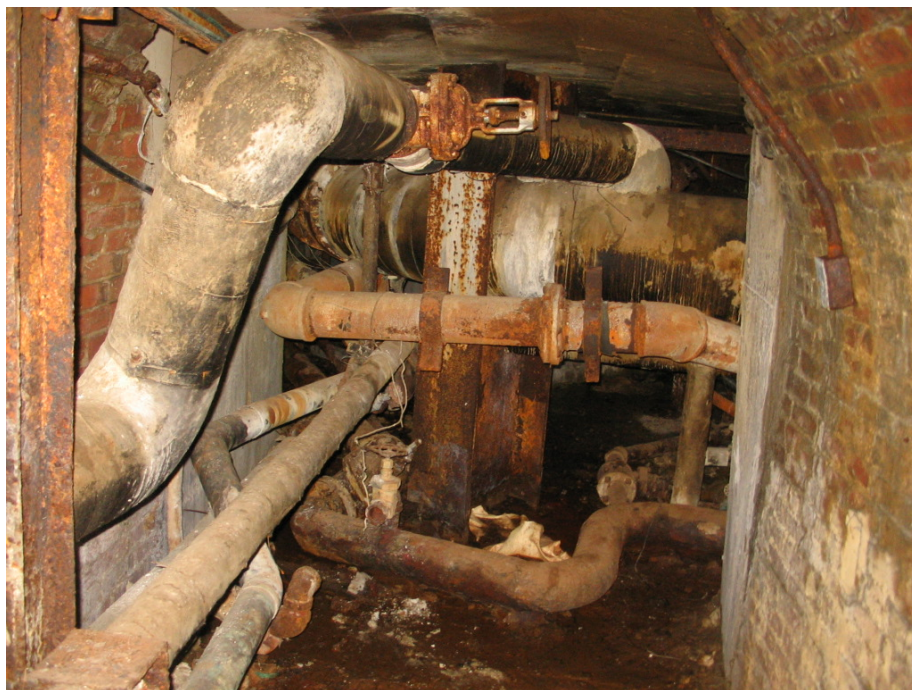
Photo 2: South Portal

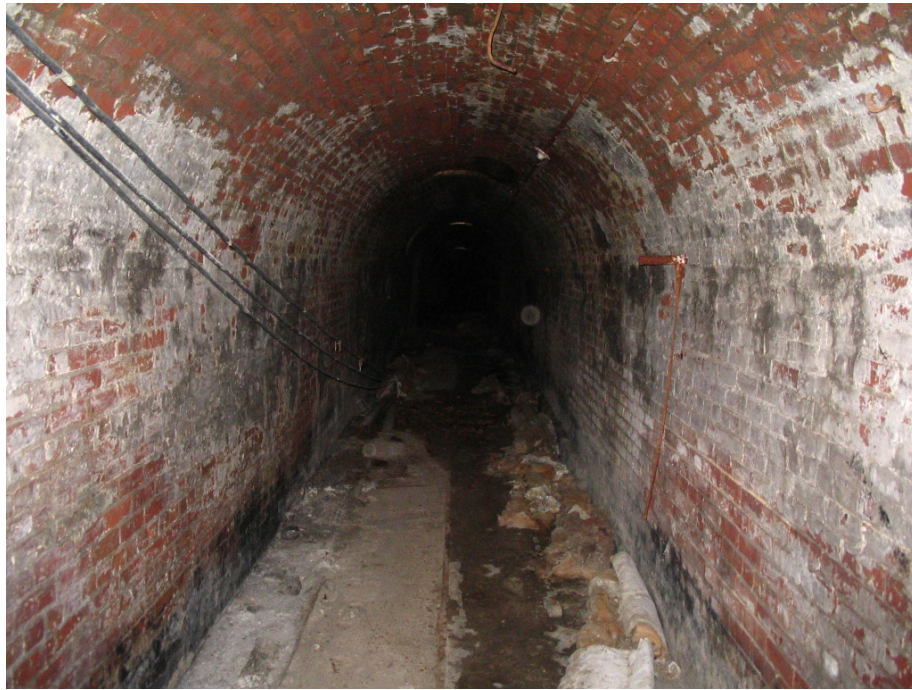
Photo 3: General view looking north from Building 34; Note downed electric lines

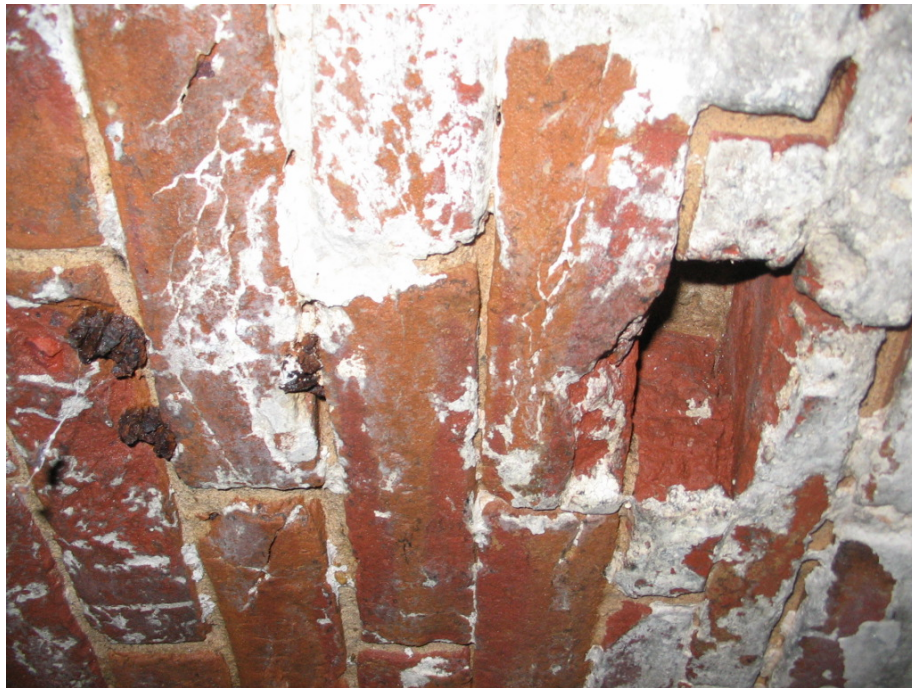
| 59.1 | Minor mortar deterioration throughout brick lining with chipped or missing bricks in several locations. |

Photo 4: Typical deteriorated mortar joints in lining; Note chipped and missing ceiling brick
